DEPARTMENT OF TRANSPORTATION

Quality Assurance and Source Inspection

Contract #: 04-0120F4Cty: SF/ALA Rte: 80 PM: 13.2/13.9File #: 1.28**WELDING INSPECTION REPORT****Resident Engineer:** Casey, William**Address:** 333 Burma Road**City:** Oakland, CA 94607**Report No:** WIR-028271**Date Inspected:** 24-Aug-2012**Project Name:** SAS Superstructure**OSM Arrival Time:** 700**Prime Contractor:** American Bridge/Fluor Enterprises, a JV**OSM Departure Time:** 1930**Contractor:** American Bridge/Fluor Enterprises, a JV**Location:** Job site**CWI Name:** Salvador Merino**CWI Present:** Yes No**Inspected CWI report:** Yes No N/A**Rod Oven in Use:** Yes No N/A**Electrode to specification:** Yes No N/A**Weld Procedures Followed:** Yes No N/A**Qualified Welders:** Yes No N/A**Verified Joint Fit-up:** Yes No N/A**Approved Drawings:** Yes No N/A**Approved WPS:** Yes No N/A**Delayed / Cancelled:** Yes No N/A**Bridge No:** 34-0006**Component:** OBG**Summary of Items Observed:**

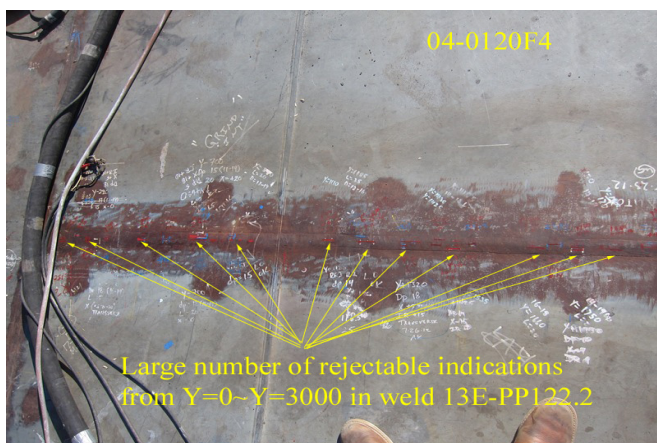
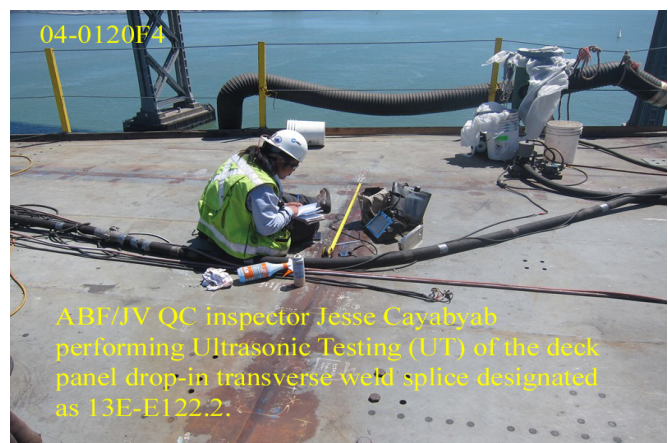
OBG 13E Deck Drop-in (13E-PP122.2)

This QAI observed ABF/JV QC inspector Jesse Cayabyab performing Ultrasonic Testing (UT) of the deck panel drop-in transverse weld splice designated as 13E-E122.2. The weld was being re-inspected ultrasonically after being rejected by the QAI for multiple missed indications on 08-22-2012. The ABF/JV QC inspector discovered a large number of rejectable indications from Y=0~Y=3000 as seen in the attached photograph.
